Take another look at polybutylene plumbing

by Kenny Hart, ASHI Technical Committee Member

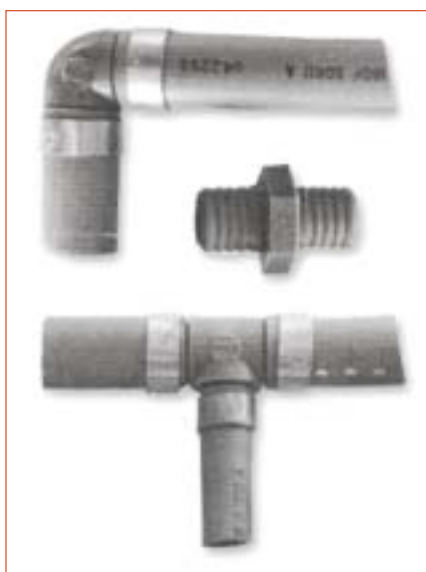
Plastic or acetal type fittings with aluminum crimp rings

Initially, aluminum crimp rings and plastic or "acetyl" fittings

Problematic aluminum rings and the acetyl fittings caused concern after the walls went up. The industries' solution was to use copper or brass fittings along with copper crimp rings. In some localities, bags of the unused parts cart-

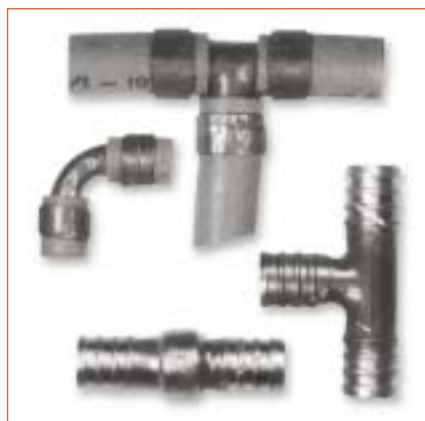
Copper fittings with copper crimp rings

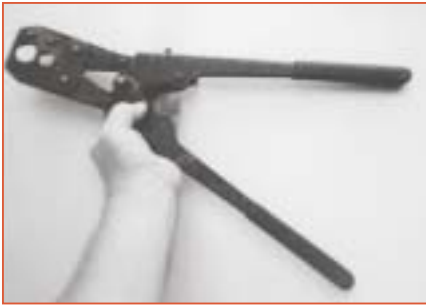
Combination crimp tool

The combination crimp tool was the next to go. Though popular when first sold, it wasn't easy to place it around the ring and still get the proper crimp action required to set the joint. The combination tool also had space limitations, and it was difficult to keep it adjusted. By the mid 80s, suppliers stopped selling it, urged plumbers to throw it away and to replace it with a single crimping tool for each pipe size. Plumbers who purchased large quantities of PB pipe sometimes received the new tools free-of charge.

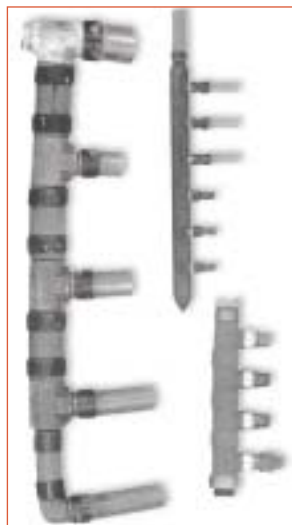
On site and factory made manifold units

“Home Run Plumbing”, involved pulling a series of 1/2" pipes from the hot and cold service locations behind each fixture to one location in or under the house.

rolls. Because the rolls of tubing could be purchased at 100 feet or more, the need to install fittings along the way on a manifold system was eliminated – a plus because fewer fittings meant fewer potential leaks.

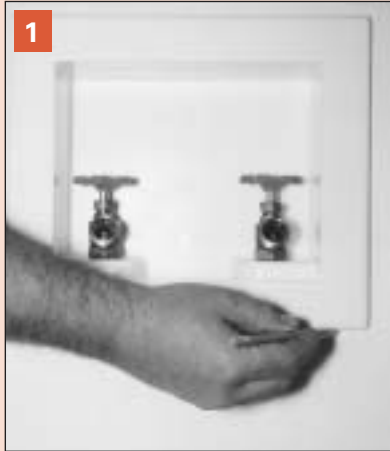
PB pipes are often not visible in slab homes and wiggling the pipes can be risky. The washing machine utility box is a good place to look for PB pipes.

Lightly mark the edge of the box trim frame and remove it.

When inspecting a slab home, where there is no PB visible below sinks, behind water heaters, under jetted tubs or in the attic, I recommend trying to check the washing machine utility box. Though some inspectors check at the water meter, this doesn't necessarily determine if the problematic pipe is in the wall. It may indicate the possibility that the yard service line is polybutylene. A common practice for plumbers was to connect the polybutylene piping directly to the service valves (boiler drains), thread the pipe through the 1/2" valve hole at the washing machine box and use a lock nut to secure the valve at to the box.

Remove the trim frame from the washing machine utility box, and cut or chip away a small area of plasterboard or sheetrock. If the plumbing connection is made with PB, it can almost always be discovered. When the frame is re-

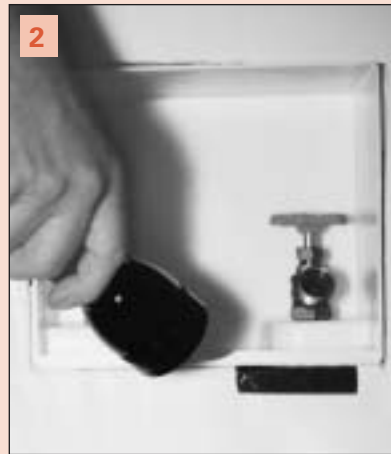
Chip or cut away a small section of wall within the frame area using the pencil mark for guidance. Check inside the wall with a flashlight for the gray pipe and metal ring.

On outer walls it may be necessary to pull the pipe wrap from around the pipe. This can usually be done with a screwdriver or other flat edge.

After your check re-install the frame.

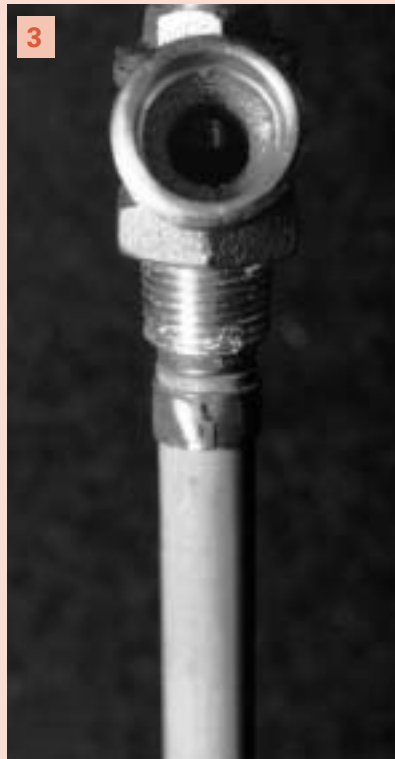
The removed valve at the left is typical of what you might see, but in some cases a compression fitting might be observed.

installed, the small hole will be covered up without any visible damage at the wall. PB can often be found at this location when there is no other evidence in the house that the pipe exists.
